## Thermography Inspection Report for

16<sup>th</sup> September 2009

<b>Thermographic inspection report</b>	<b>Location</b> Top Greenhouse <b>Equipment</b> Main DB / DBA	<b>Repair priority</b> <b>N/A</b>
--	--	--------------------------------------

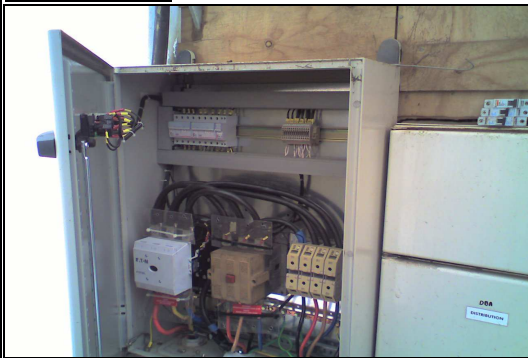
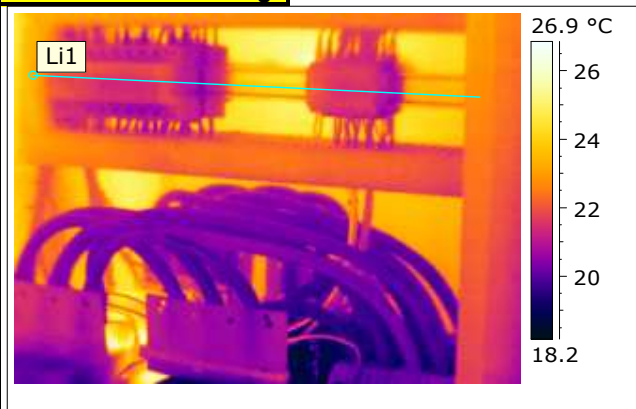
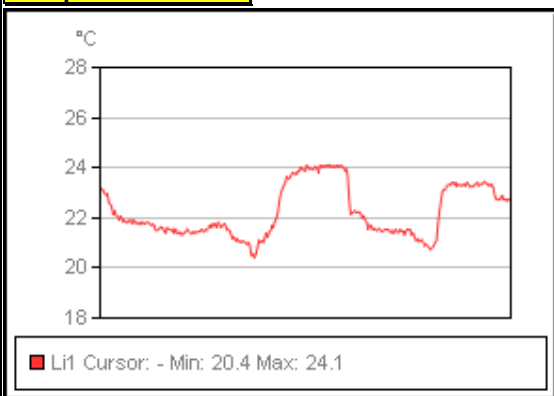
No abnormal Temperatures found  
 High points on Graph are reflection off the back of the box

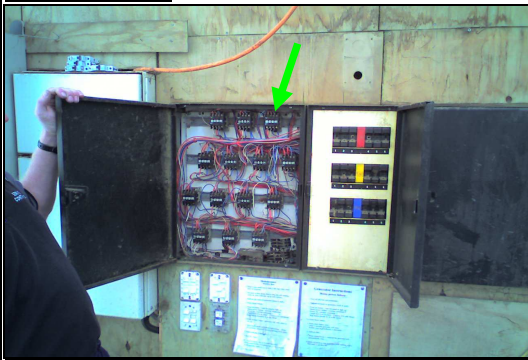
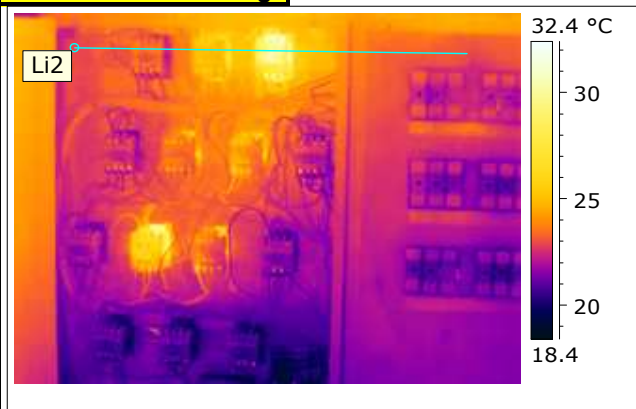
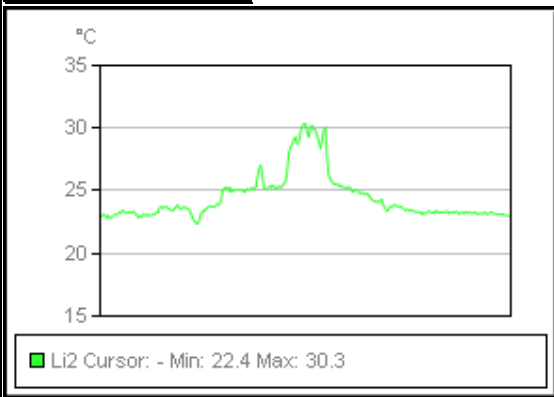
The thermal survey of the main and distribution boards in the top greenhouse did not pick up any significant concerns other than a contactor showing only a slight temperature anomaly as shown on page 4 of this report. It is suggested that this should be monitored to ensure that this does not deteriorate

Contactors running slightly warm, suggest this be monitored

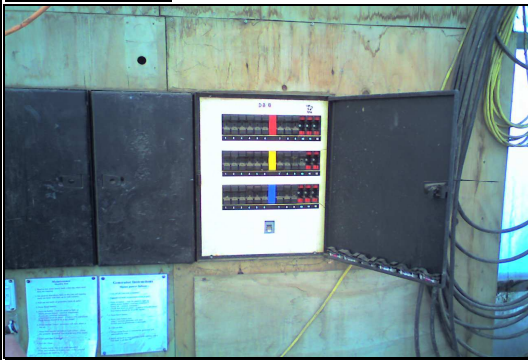
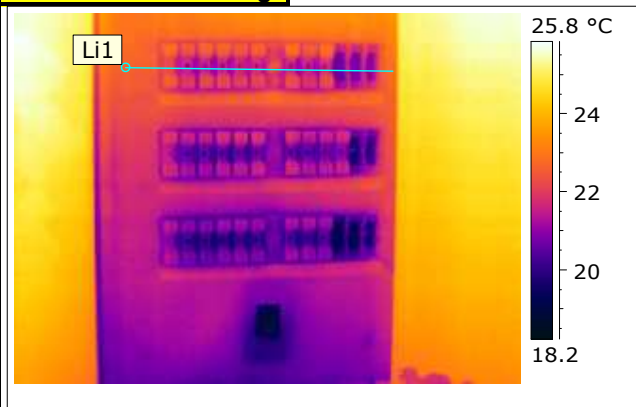
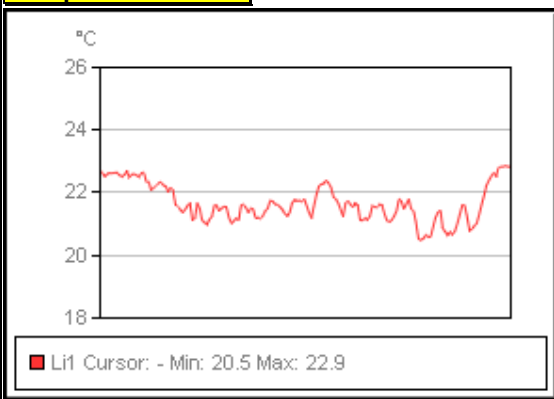
No abnormal Temperatures found

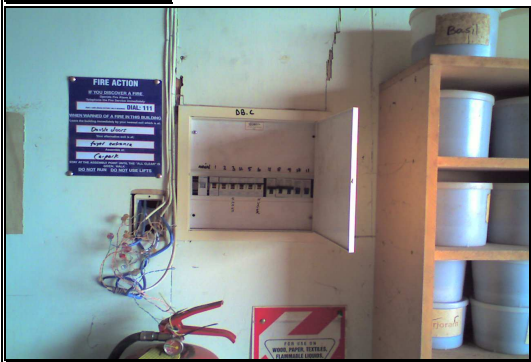
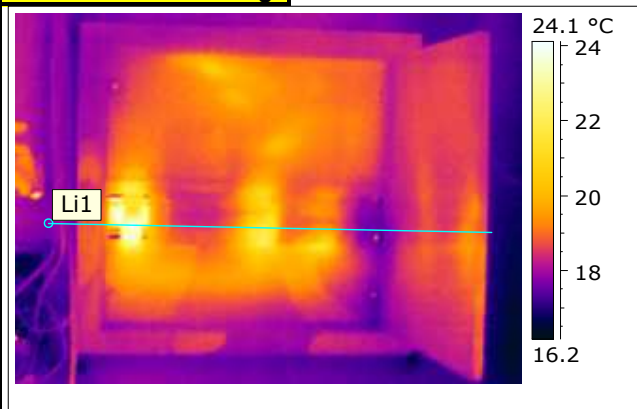
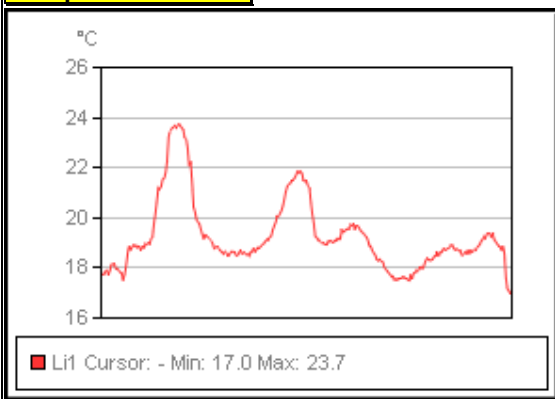
No abnormal Temperatures found  
 High points on Graph are reflection from gaps between breakers

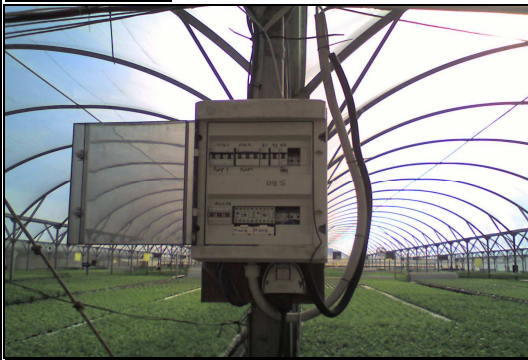
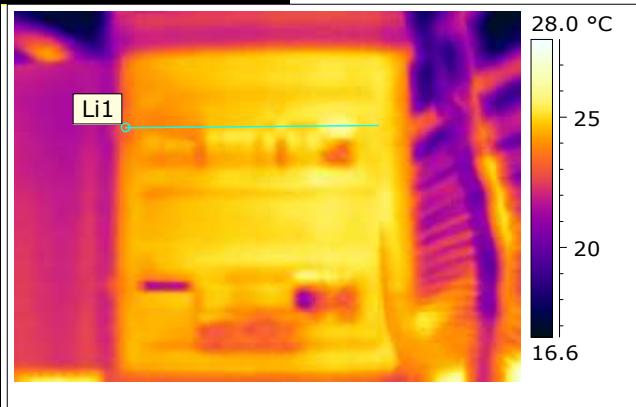
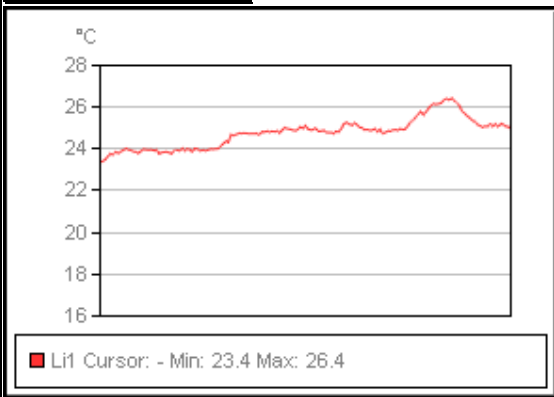
No abnormal Temperatures found  
 High points on Graph are reflection from gaps between breakers

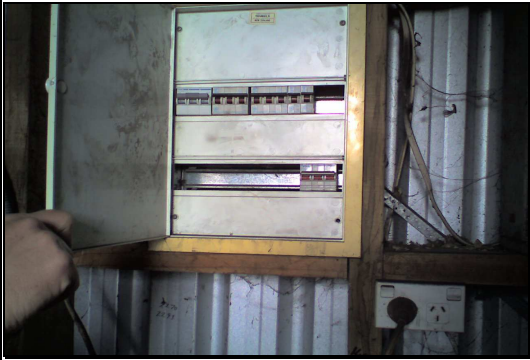
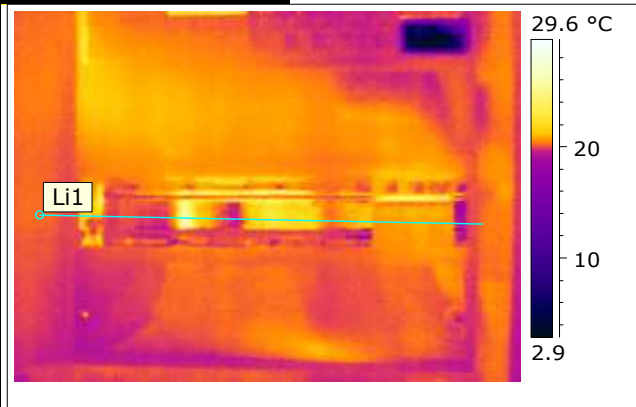
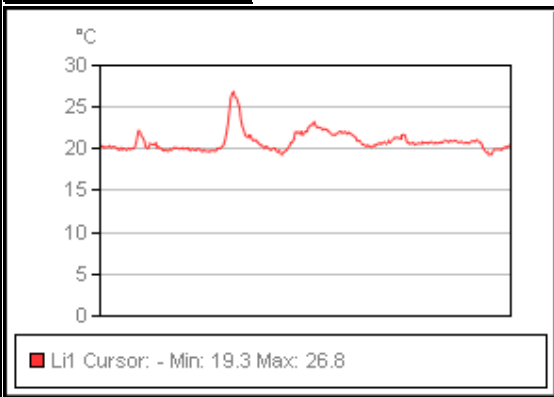
No abnormal Temperatures found  
 High points on Graph are reflection from gaps between breakers

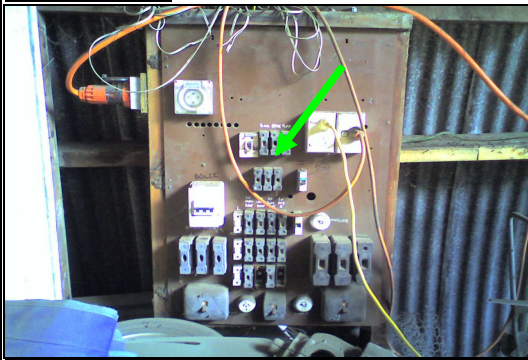
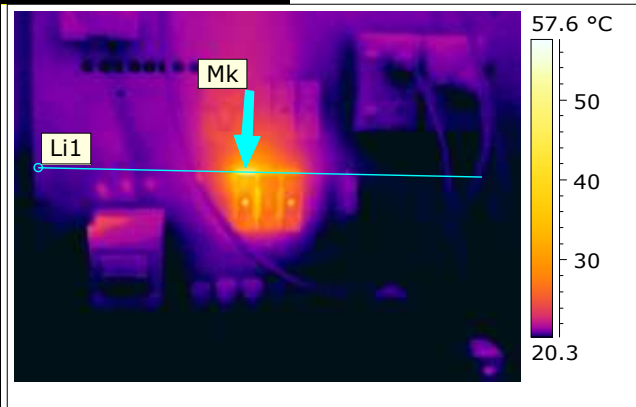
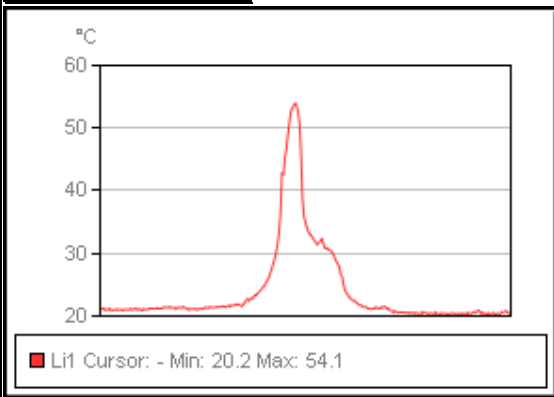
Fuse holder appears damaged, investigate and replace if required

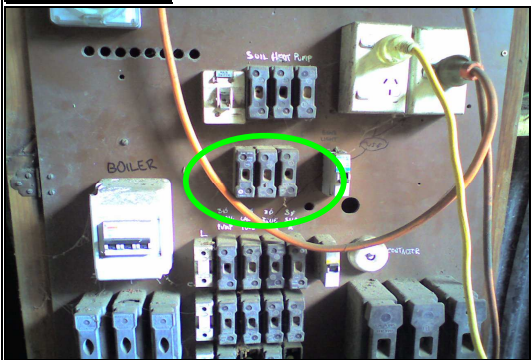
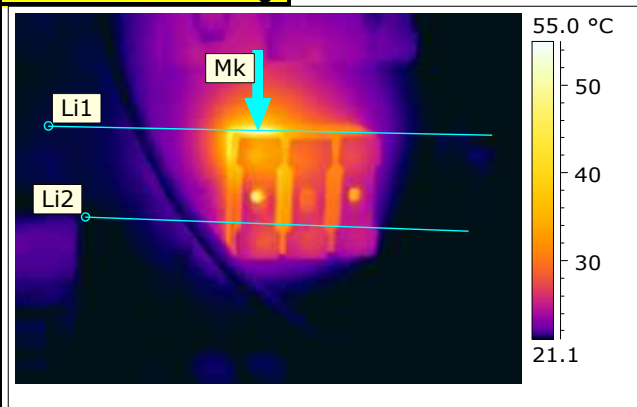
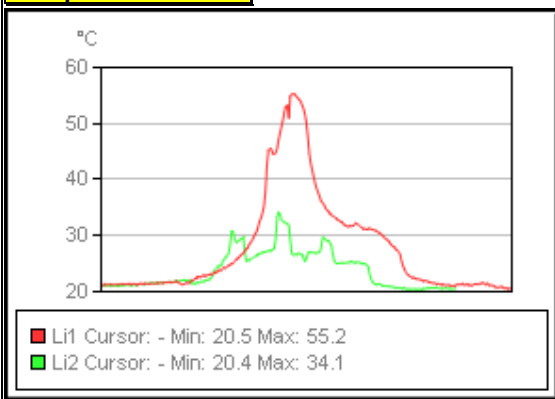
Same shot as previous page  
 Close up indicates that problem is at top of fuse

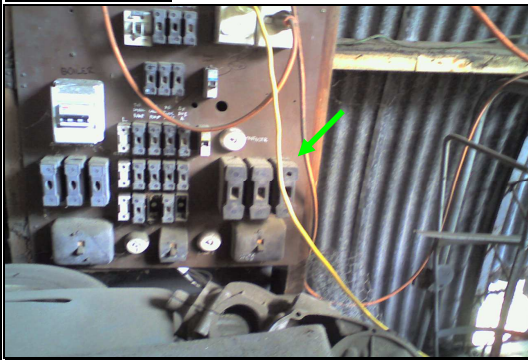
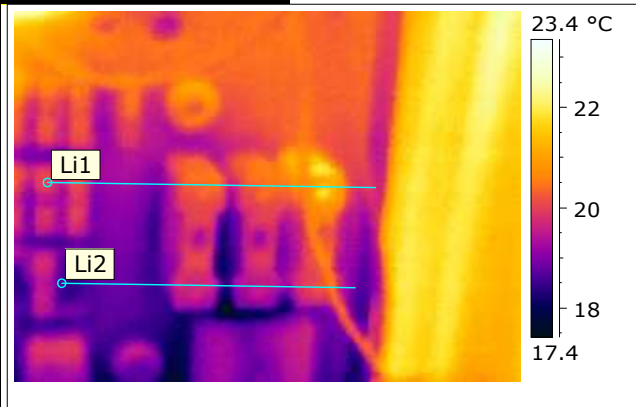
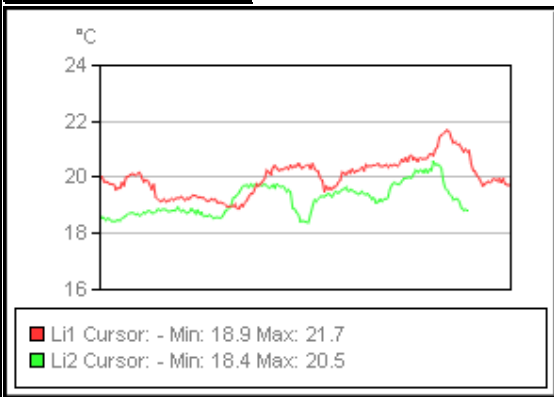
Whilst only a slight temp increase, the fact that it is one end only, may indicate a poor connection

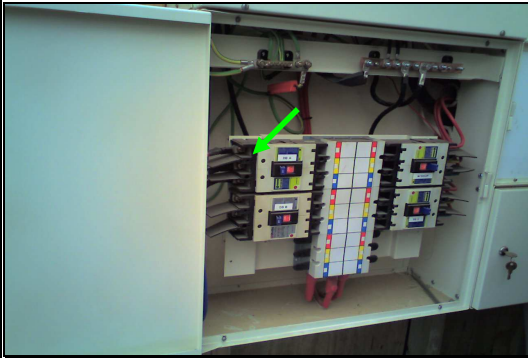
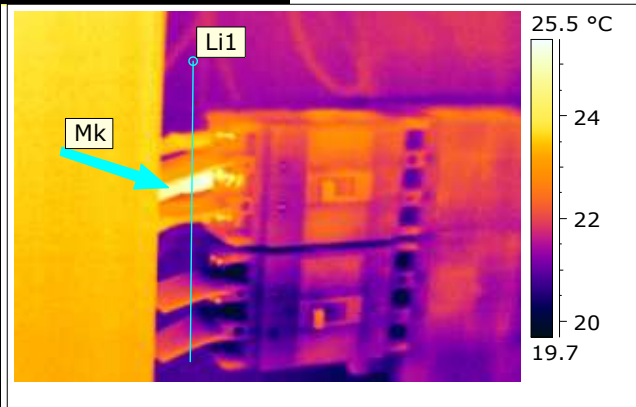
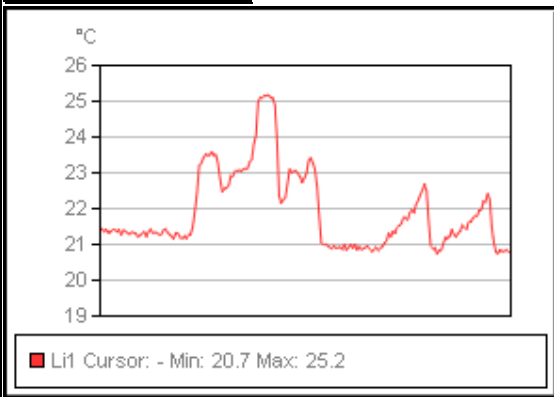
Whilst only a small increase in temp, this should be monitored as this phase appears to be carrying a greater loading than the other phases

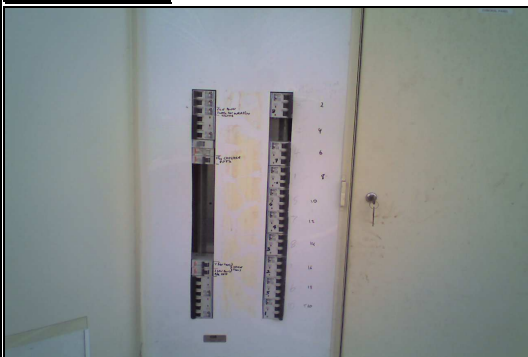
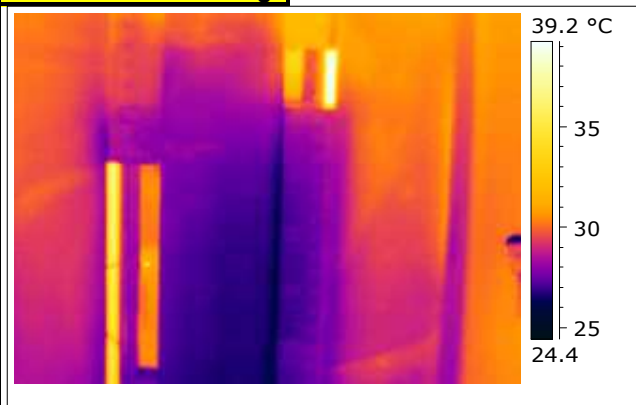
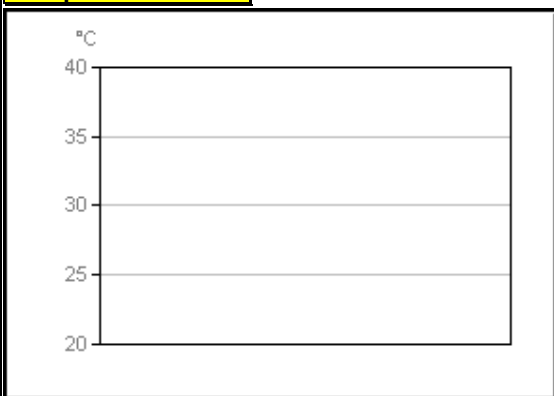
Hot spots indicated are only reflection and no problems found

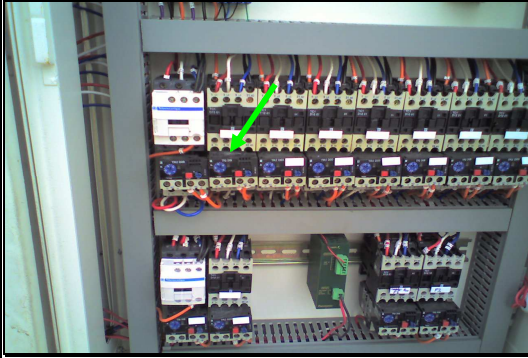
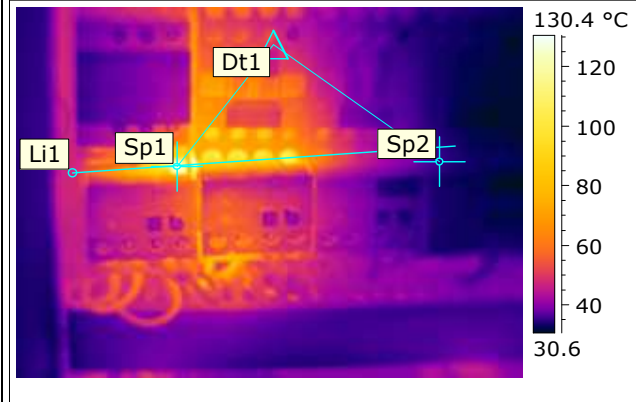
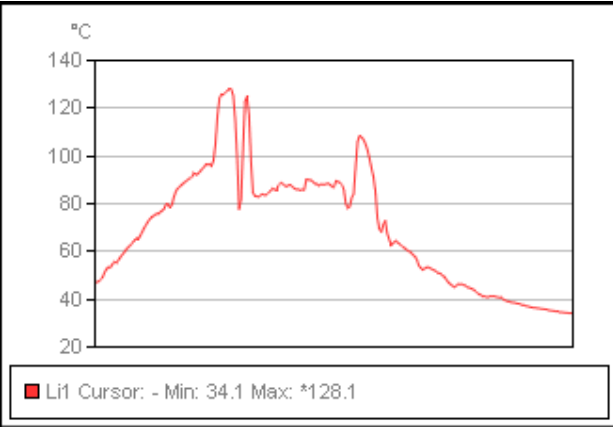
Date	16/09/09
Filename	IR_0459.jpg
Max Temperature	*130.1 °C
Min Temperature	30.9 °C
Emissivity	0.95
Atmospheric Temperature	20.0 °C
Sp1 Temperature	*127.6 °C
Sp2 Temperature	35.3 °C
Dt1 Value	92.3

Contactor showing excessive heat possibly caused by suspected bad connection. Needs urgent investigation and repair

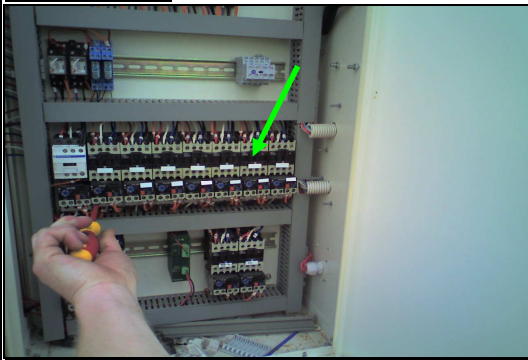
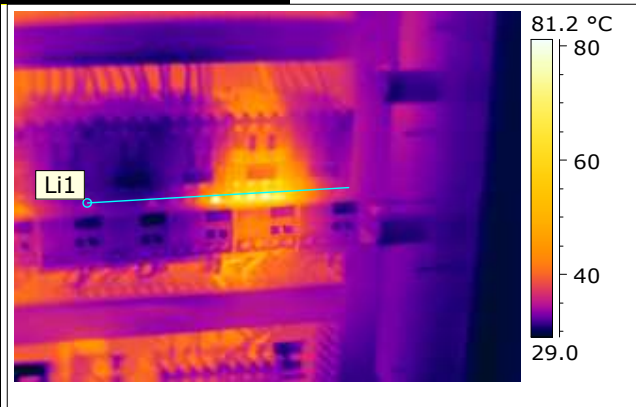
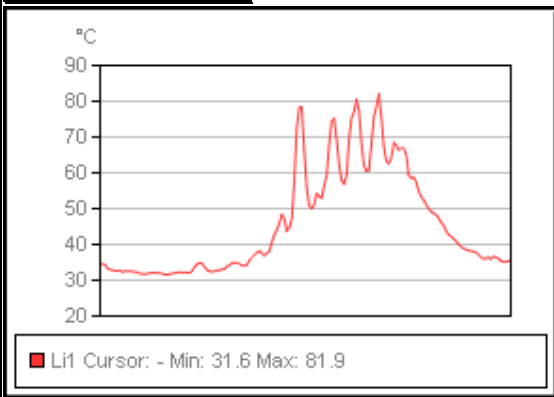
Contactor showing excessive heat possibly caused by suspected bad connection. Needs urgent investigation and possible repair or replacement
